## Porterhouse Home Inspections, LLC

**Report:** Sample Report

# Confidential Inspection Report

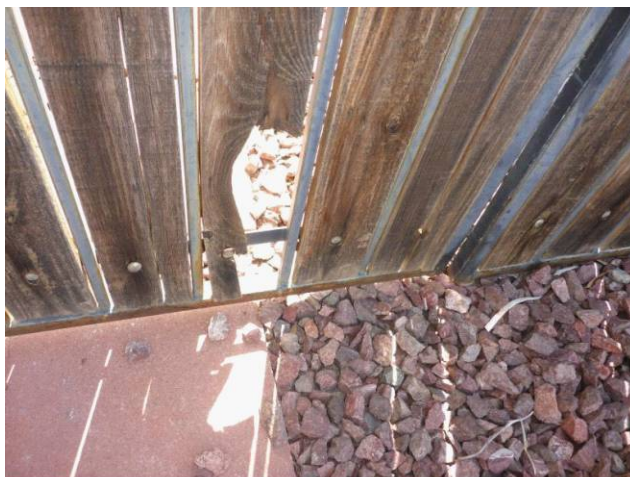
**Broken slat**

Gate(s) in generally good condition with the following noted exception (s):

**Damaged/ broken board**

**Recommend Repair.**

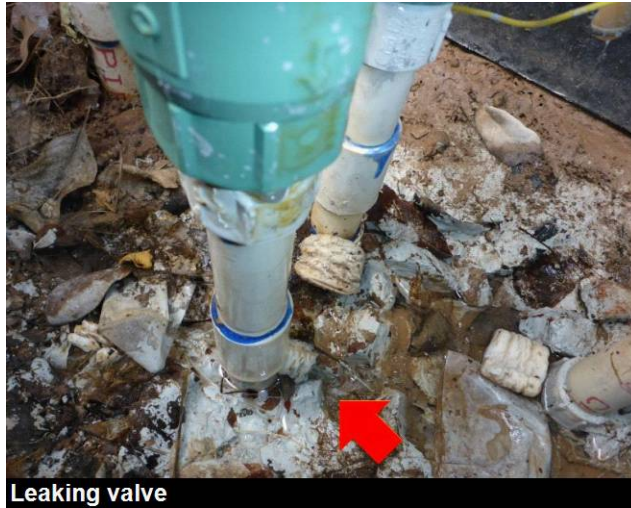
**Leaking valve**

Automatically tested and found to be in generally good condition with the following noted exception(s):

**Leaking observed at the east valve**  
**Recommend repair.**

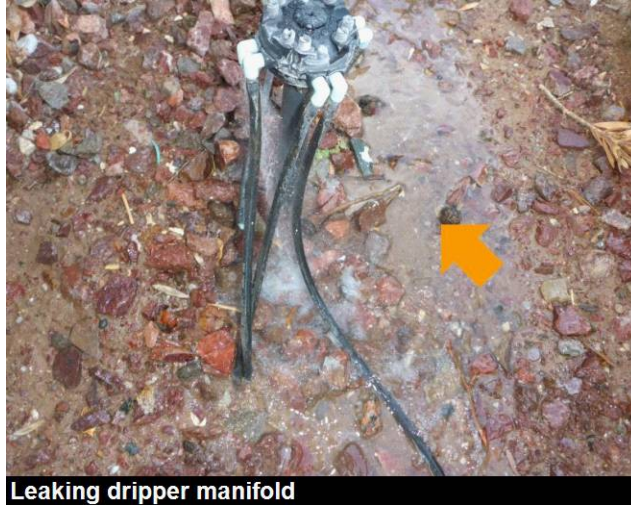
Drip system tested operable and in generally good condition with the following noted exception(s):

**Drip head manifold observed to be broken at the front yard  
Recommend repair**

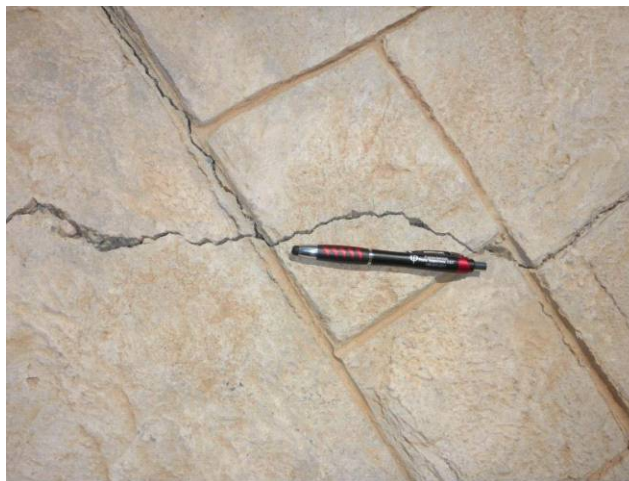
**Typical concrete cracks**

Pool Deck observed in generally good condition with the following noted exception(s):

**Typical cracks for age of surface.**

**Recommend monitor and repair as needed.**

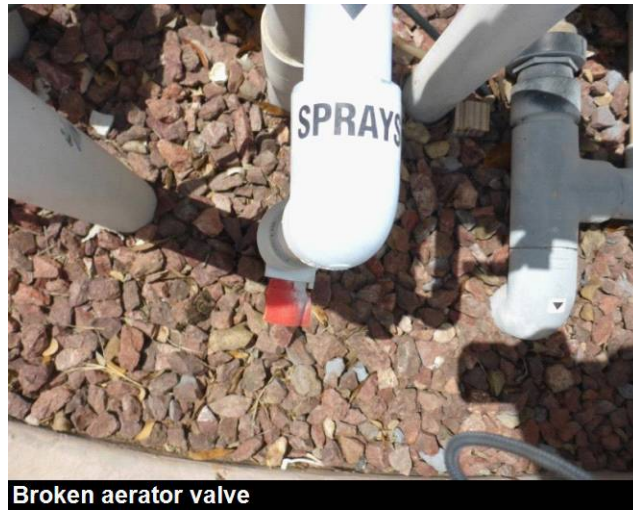
Broken aerator valve

**Aerator valve is broken.  
Recommend replacing/repairing for proper operation.**

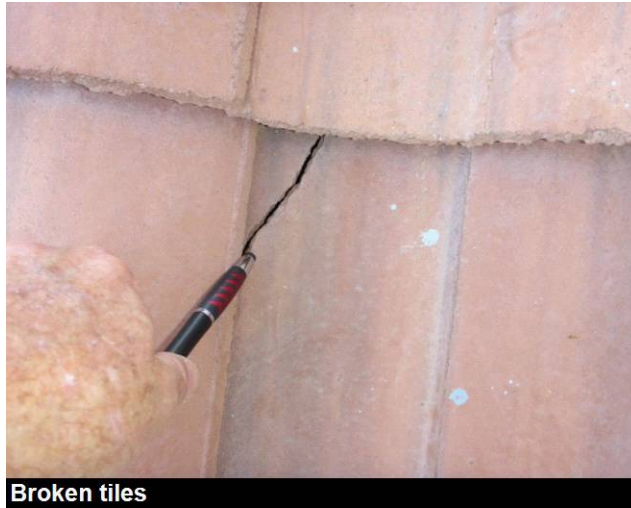
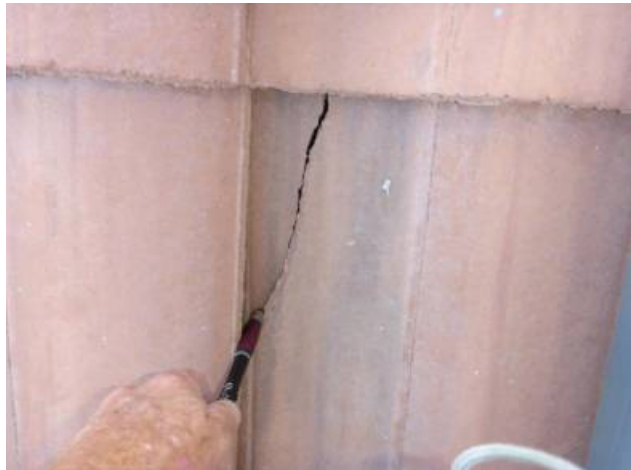
**Broken tiles**

Tile roofing material observed in good condition with the following noted exception(s):

**Broken tiles observed above the front garage**  
**Recommend Repair**

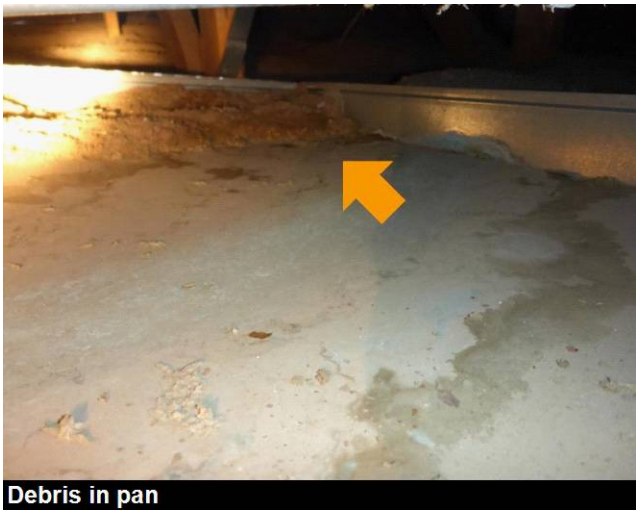
Debris in pan

Attic with drip pan observed in good condition.

Recommend cleaning insulation debris out of the north rip pan.

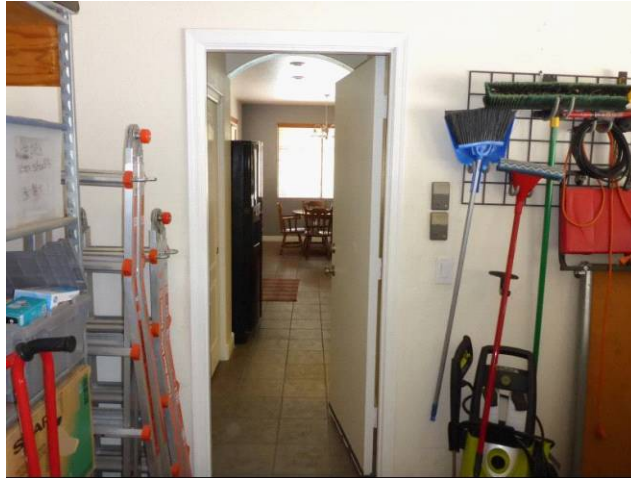
**Fire door & hinge**

Fire Door is in generally good condition with the following noted exception(s):

**Fire door did not self close as is required.**

**Repair/adjustment of self closing mechanism is recommended to ensure self closing/latching. Safety concern.**

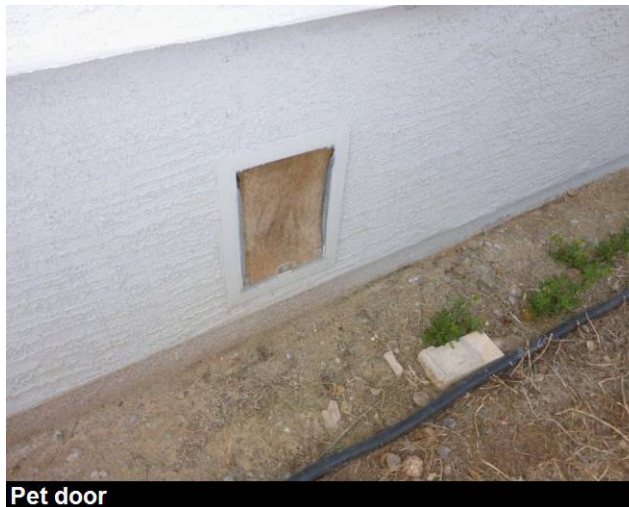
**Pet door**

**b) Pet door observed installed at the breakfast nook.  
Reminder: Recommend securing pet door/s leading into the interior of house when not in use.  
Pet doors have historically been used by intruders to gain entry to house and children to gain access to the pool.**

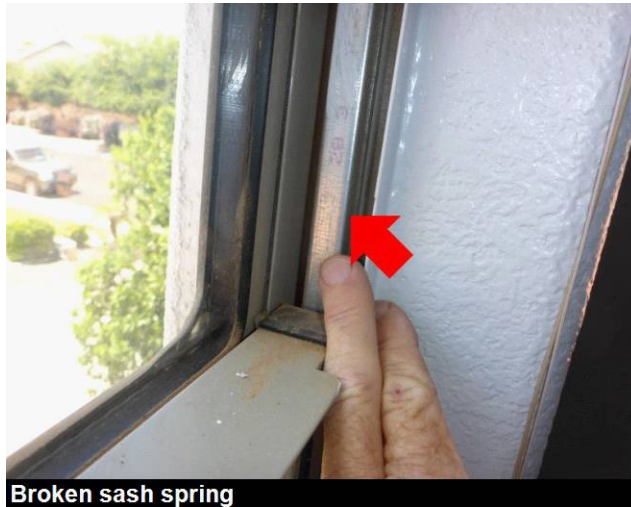
All accessible windows were tested and found to be in generally good condition with the following noted exceptions:

**Damaged/broken sash springs viewed at the SW master bedroom window**  
**Recommend repair.**

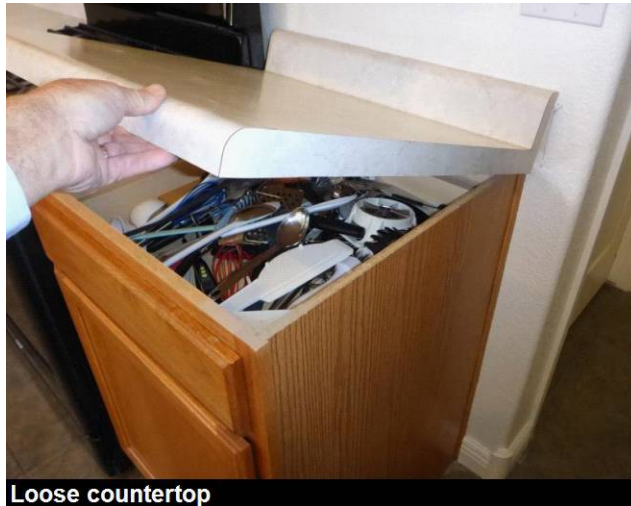
**Loose countertop**

**Loose countertop to the right of the range should be re-secured.**
