Porterhouse Home Inspections LLC

Report: Pre-drywall Sample Report

Inspection Report

Sample Address
Anywhere, AZ

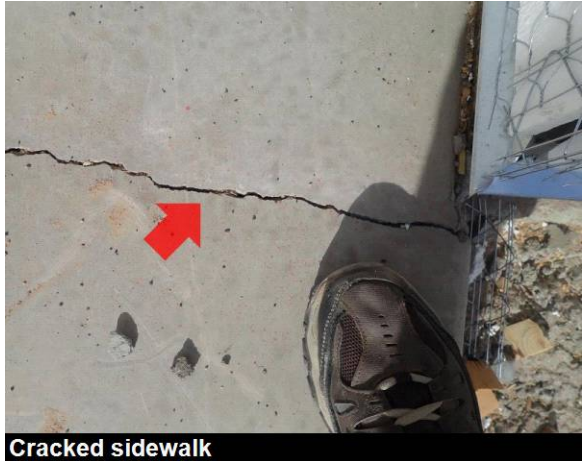
**a) Large cracks observed at the front entryway
Recommend builder review above noted condition(s) and repair as required.
(Recommend remove existing concrete & re-pour)**

Cracked sidewalk

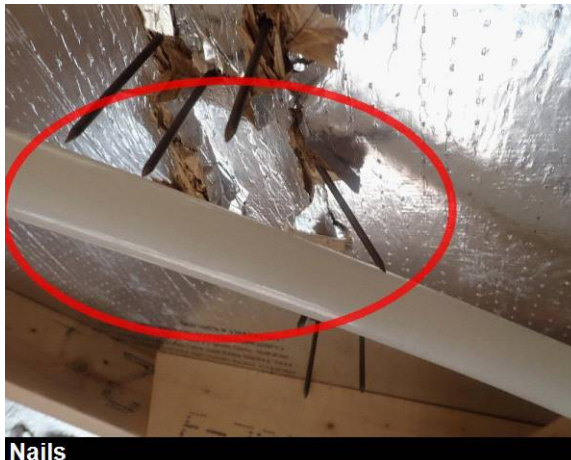
- a) Numerous locations noted where the PEX plumbing comes in contact with the sharp edge of either the truss gussets or the metal nail plates
 - b) Roofing nails touching the PEX plumbing near the service entrance
- Recommend securing the plumbing lines away from the metal gussets & relocating the metal nail plates.

Nails

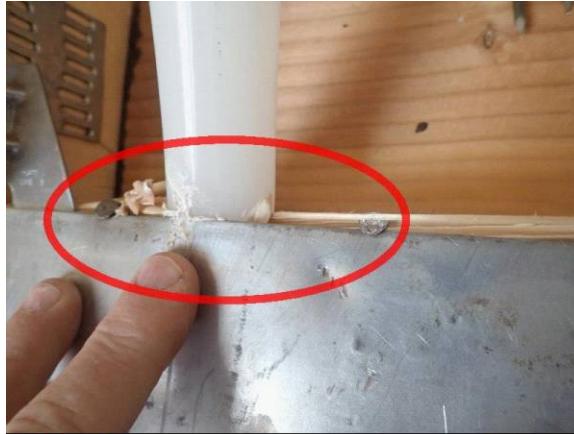
Nailer plate

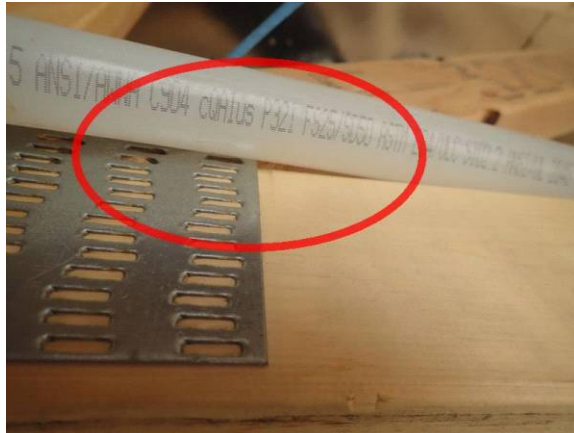
Gusset plate

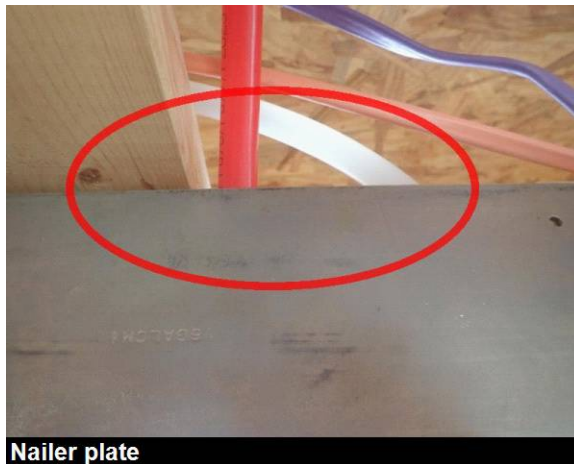
Nailer plate

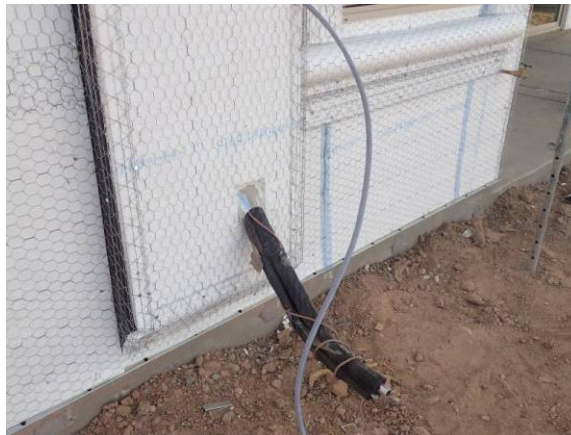
AC location at master bedroom window

**a) Central type, located at exterior between the master bedroom windows
Recommend moving compressor to the east exterior wall to reduce noise at the master bedroom.**

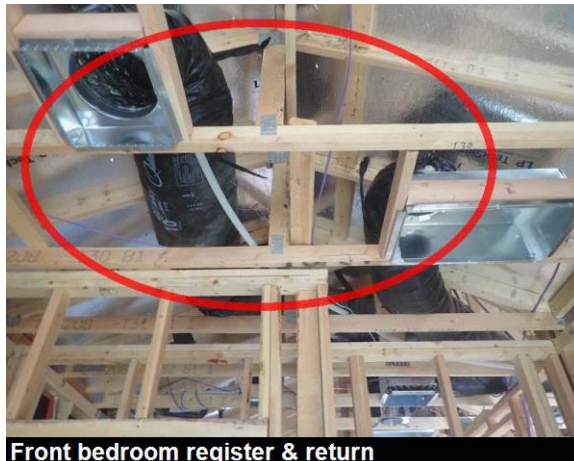
a) The register & the active return at the front bedroom are so close together air circulation may be impeded

Front bedroom register & return

Recommend builder review above noted condition(s) and repair as required.

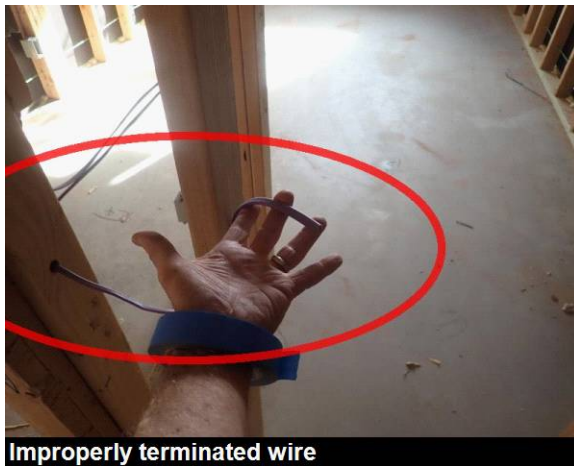
- a) In numerous locations the wiring rests on or touches the sharp edge of the truss gusset plates
- b) Missing nailing plates noted at various locations
- c) Improperly terminated wire noted at the south wall of the hall bath
- d) The bathroom exhaust fans (four) have not yet been roughed in. Possible to do late but much easier now

Improperly terminated wire

Recommend builder review of above noted condition(s) and repair as required.

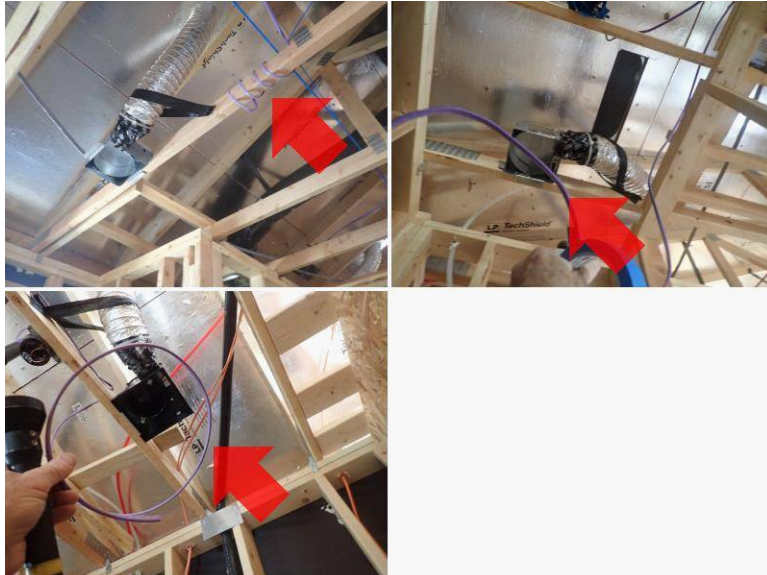
Bathroom exhaust fans

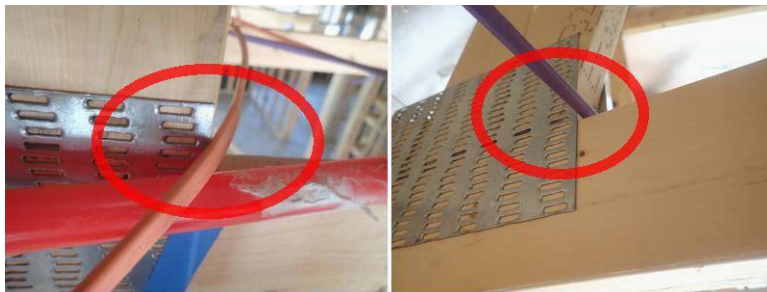
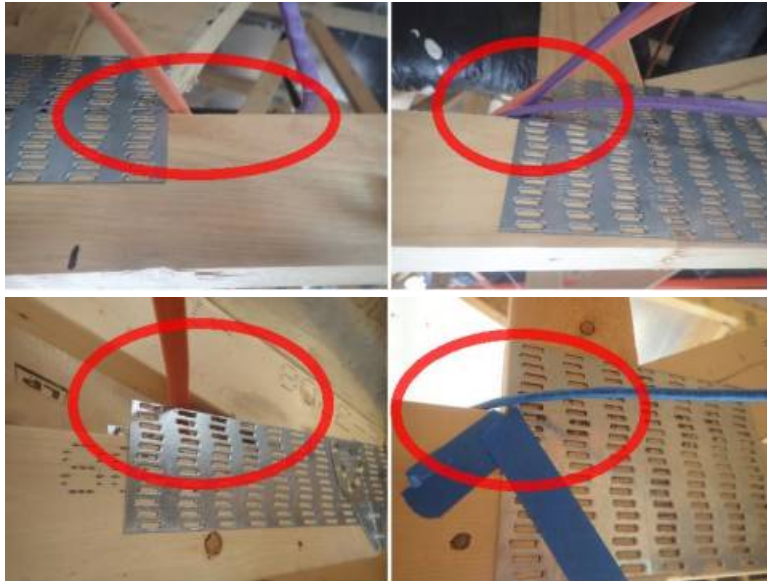
Wires touching metal gussets

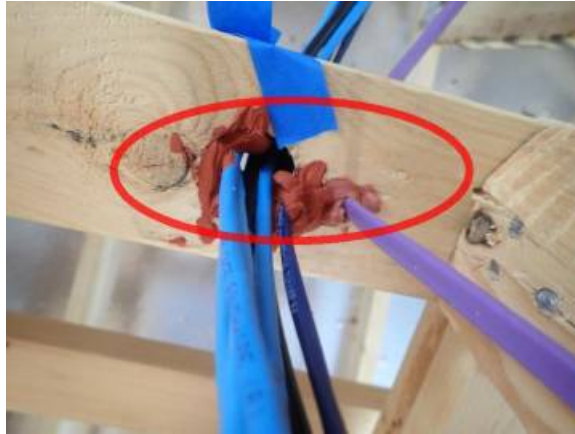
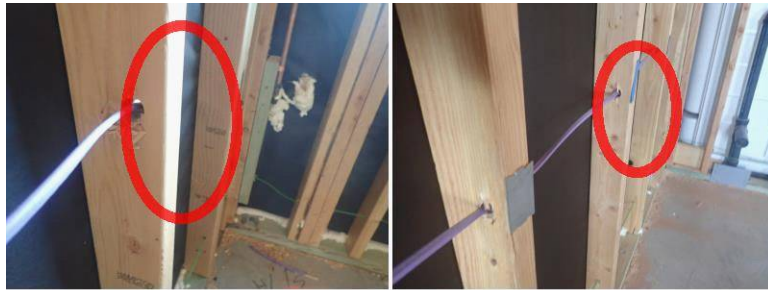
Missing nail plates

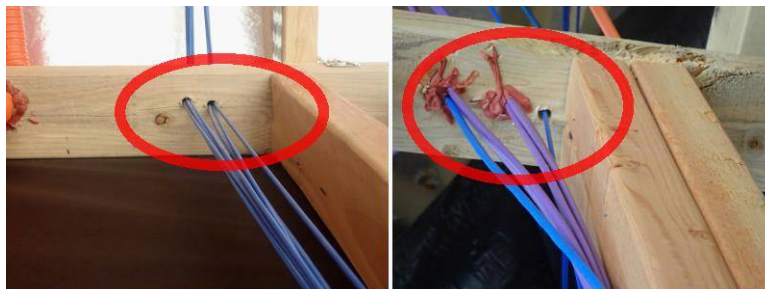
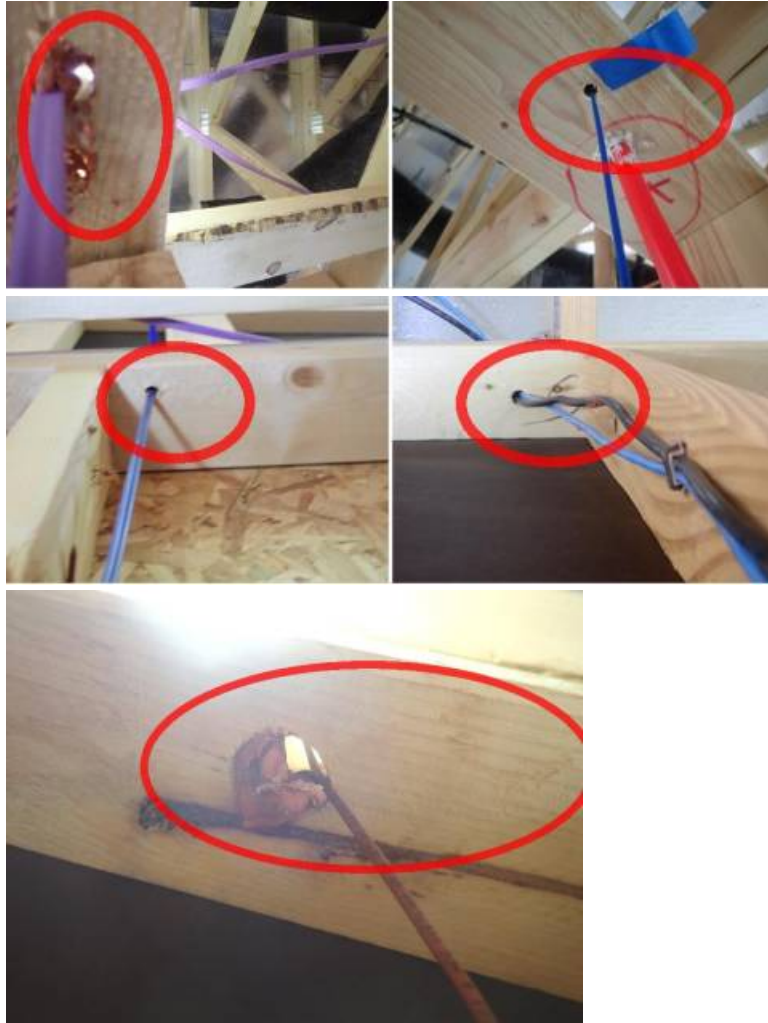
a) Fire caulking either missing or done poorly at numerous locations. (See pictures & blue tape examples)

Fire caulking

Recommend builder review of above noted condition(s) and repair as required.
