Porterhouse Home Inspections LLC

Report: Pre-drywall Sample Report

Inspection Report

Sample Address
Anywhere, AZ

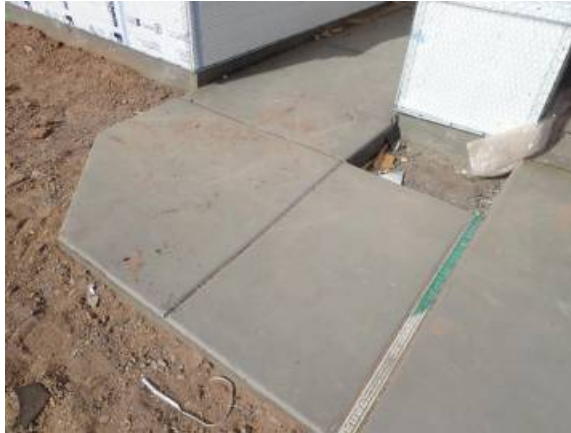
Cracked sidewalk

Sidewalk is in generally good condition with the following noted exception(s):

**a) Large cracks observed at the front entryway
Recommend builder review above noted condition(s) and repair as required.
(Recommend remove existing concrete & re-pour)**

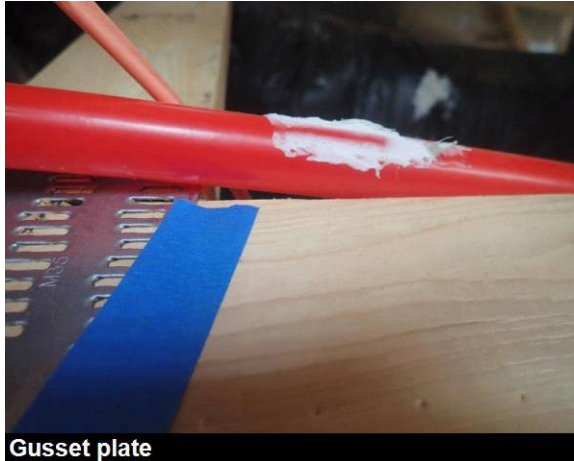
Distribution valves observed in generally good condition with the following noted exception(s):

- a) Numerous locations noted where the PEX plumbing comes in contact with the sharp edge of either the truss gussets or the metal nail plates
 - b) Roofing nails touching the PEX plumbing near the service entrance
- Recommend securing the plumbing lines away from the metal gussets & relocating the metal nail plates.
