## Porterhouse Home Inspections, LLC

**Report:** Sample Report

# Confidential Inspection Report

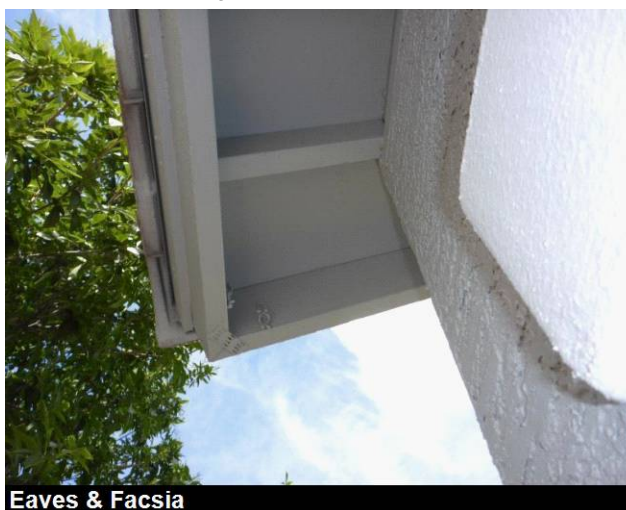
**Eaves & Fascia**

2.7 MATERIAL: Wood.  
2.8 CONDITION: Eaves observed in good condition.  
Fascia observed in good condition.

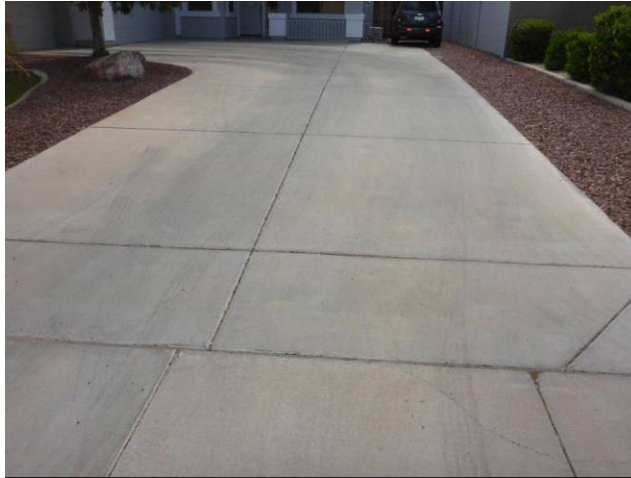
**Driveway**

In good condition.

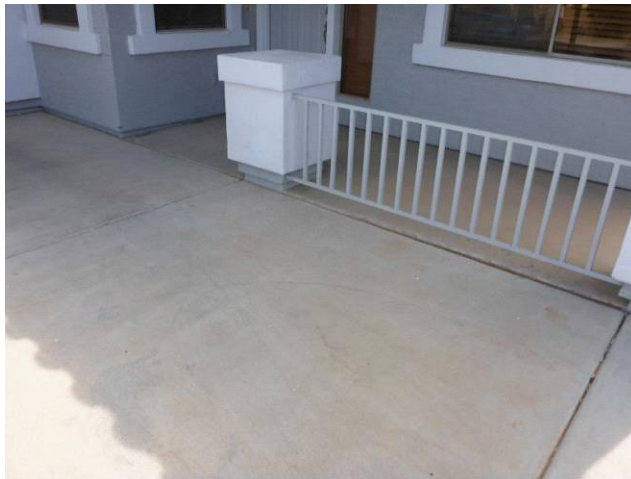
**Walkway**

In good condition.

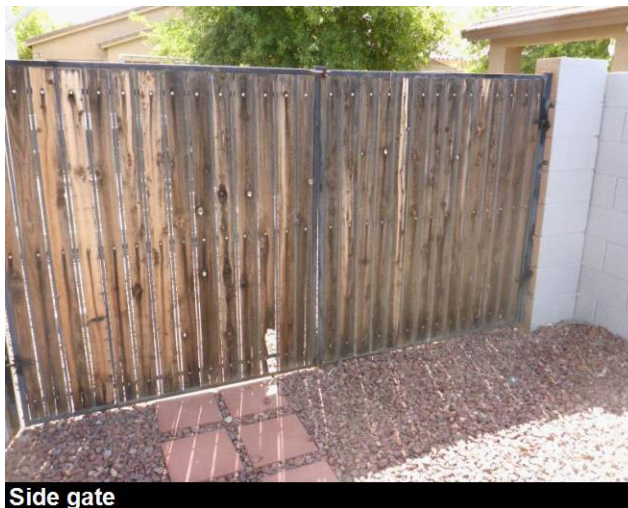
**Side gate**

Gate(s) in generally good condition with the following noted exception (s):

**Damaged/ broken board**

**Recommend Repair.**

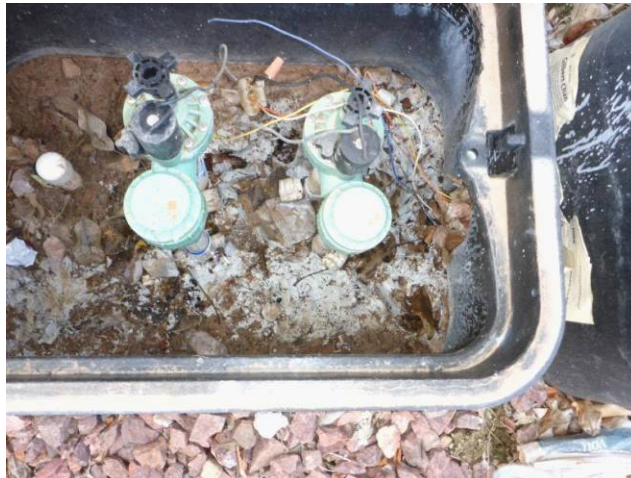
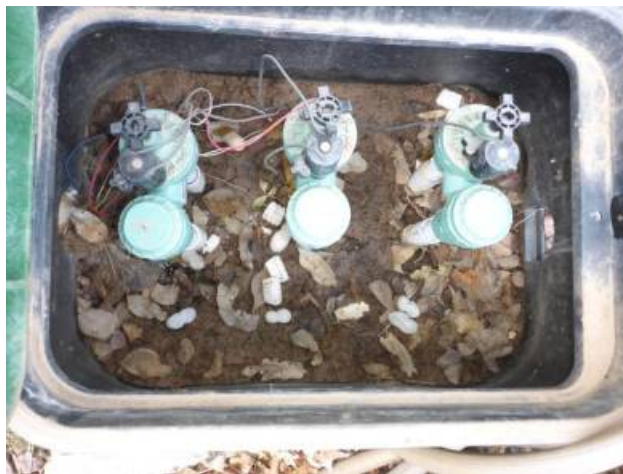
Irrigation valves

Automatically tested and found to be in generally good condition with the following noted exception(s):

**Leaking observed at the east valve**  
**Recommend repair.**

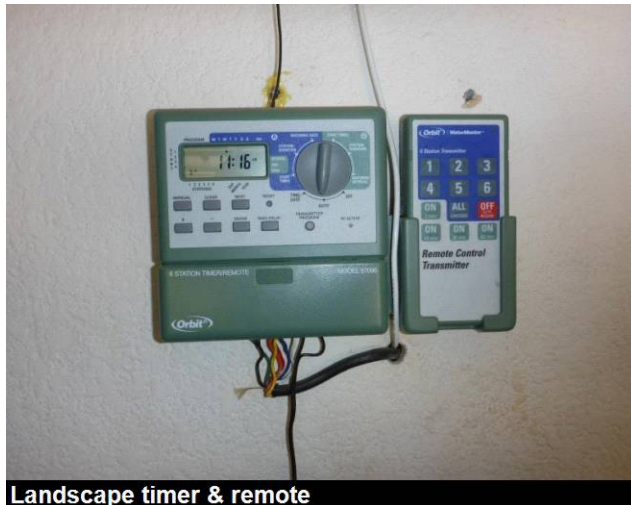
**Landscape timer & remote**

**One timer, Automatic Irrigation Control Timer unit/s located at garage  
Timer tested operable and in good condition.**

**Suggest that the buyer review manual and automatic operation including timer  
settings with seller to ensure proper operation of the system.**

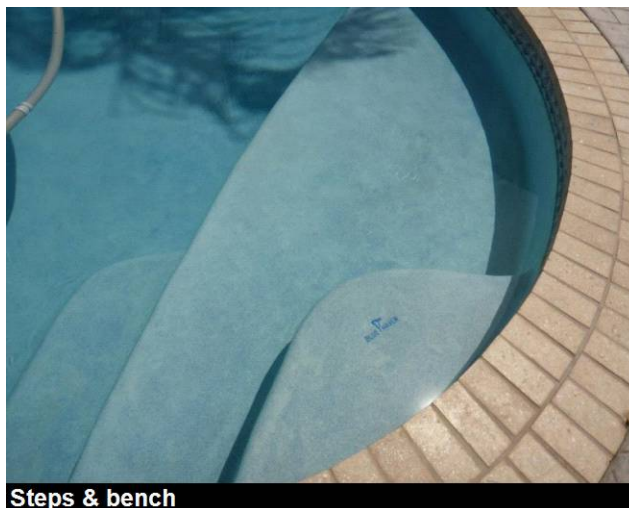
**Steps & bench**

Internal Steps and Seats observed in good condition.

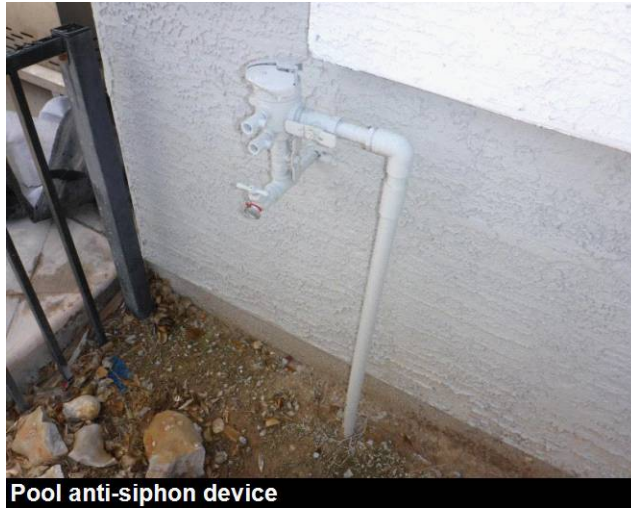
**Pool anti-siphon device**

Anti Siphon valve/ device observed in good condition

Note: Suggest covering plumbing to protect from freezing during periods of frost warnings.

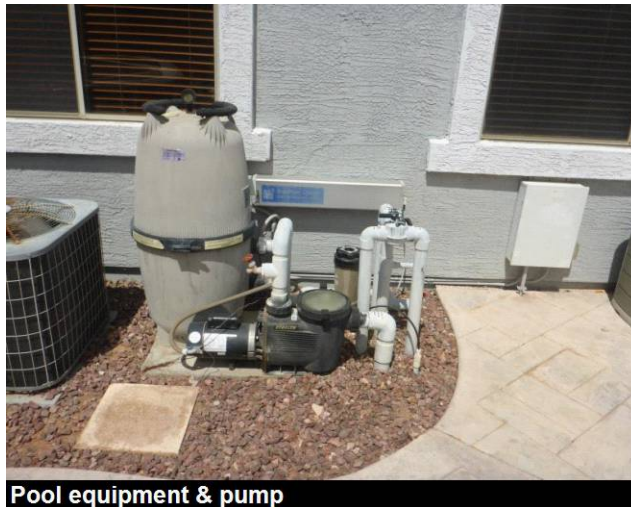
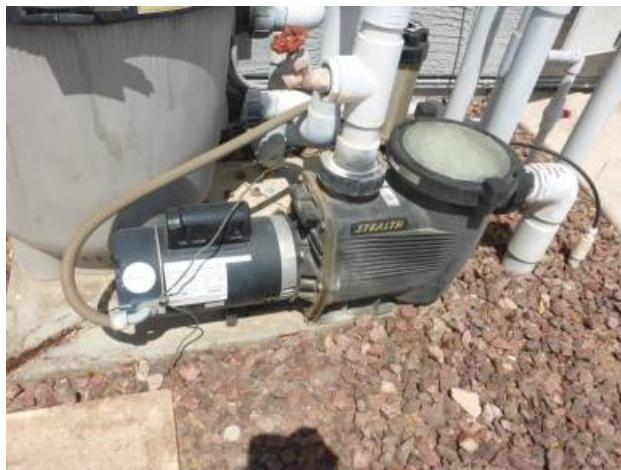
**Pool equipment & pump**

**5.10 PUMP/MOTOR CONDITION:** One Pump/Motor installed. Tested Operable. Good Operation  
Motor Ground/Bonds observed in good condition.

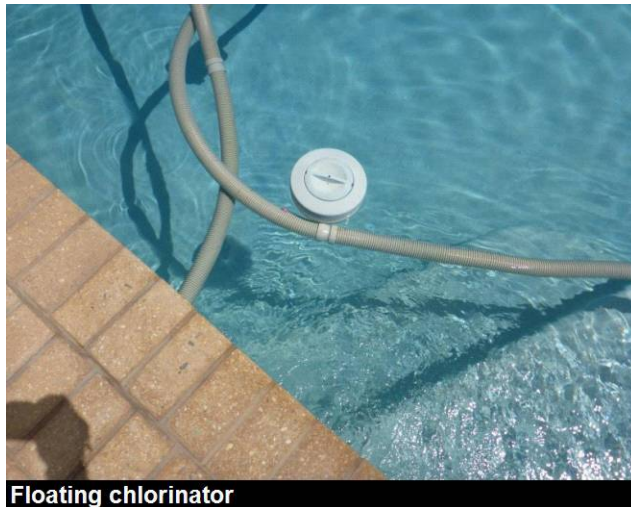
**Floating chlorinator**

**Observed in good condition.**

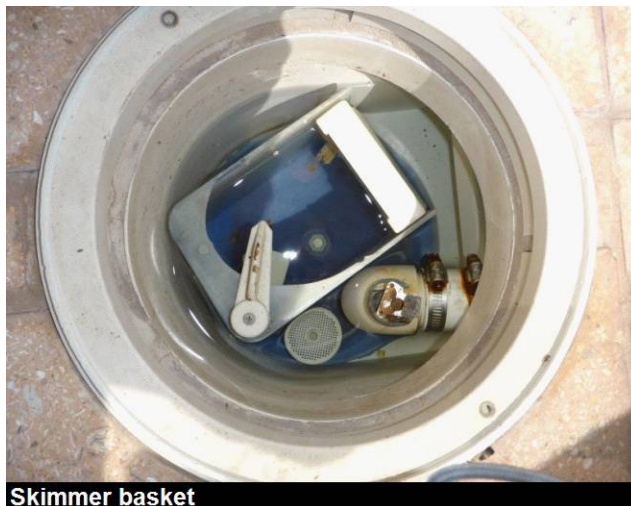
**Skimmer basket**

In good condition.

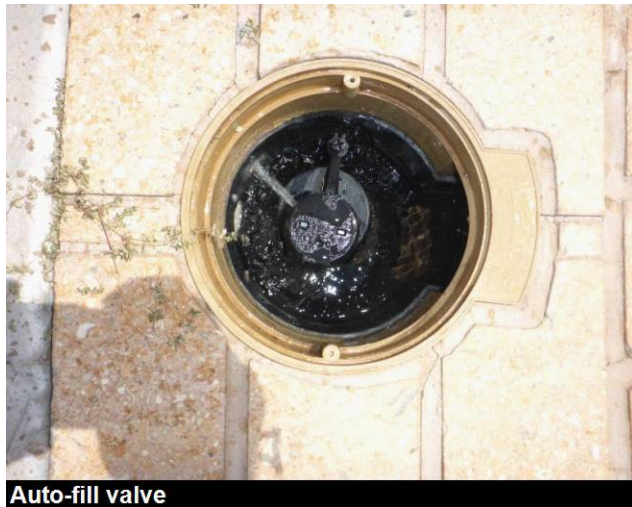
**Auto-fill valve**

Tested Operable.

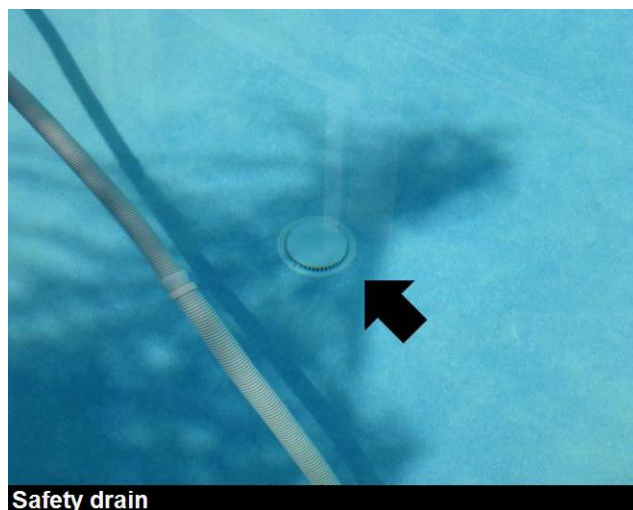
Safety drain

Anti Vortex drain cover installed at main drain cover.

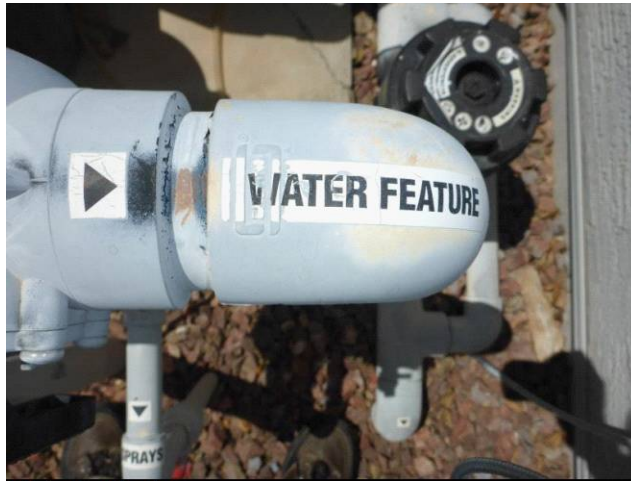
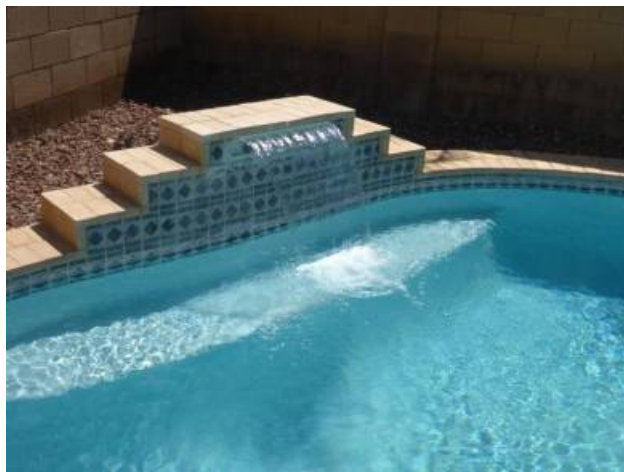
Waterfall feature

Water feature tested operable.

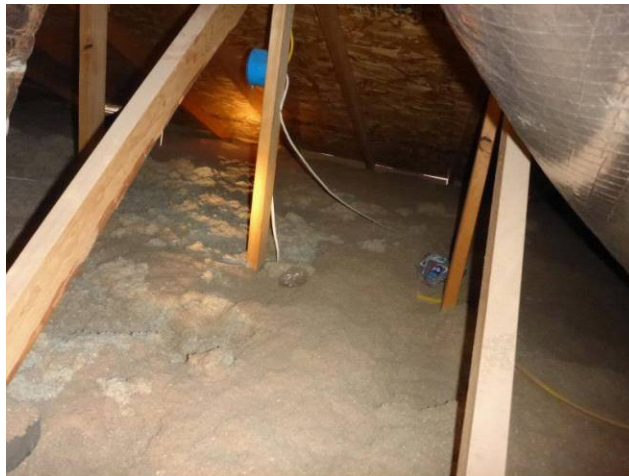
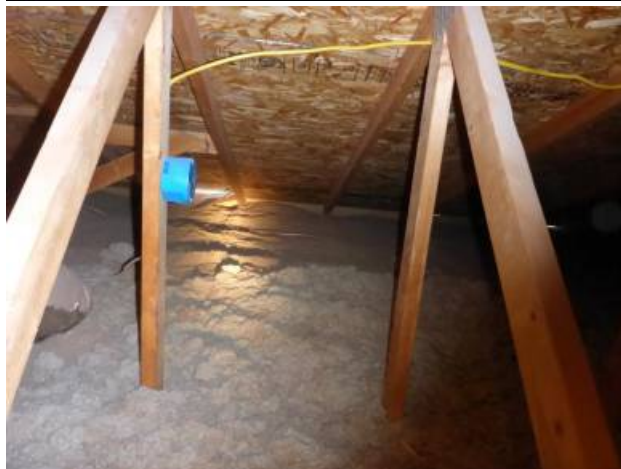
Attic views

Attic area accessible at time of inspection.

What could be seen observed to be in good condition. No signs of damage or leaks observed.

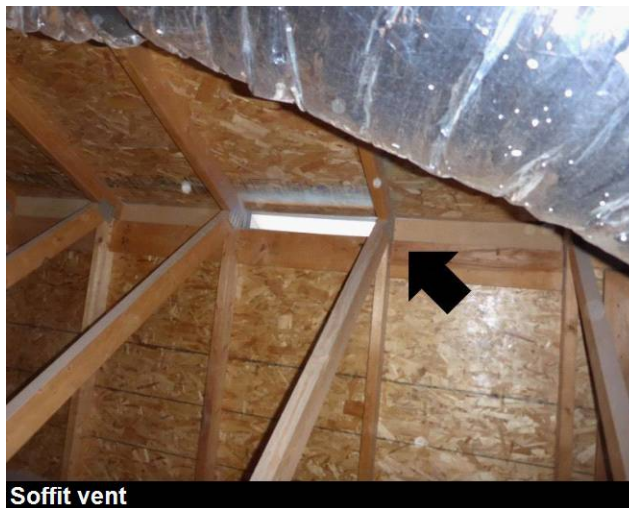
**Soffit vent**

Gable type vents provided.  
Soffit type vents provided.  
Ventilation observed in good condition.  
Screens observed in good condition.

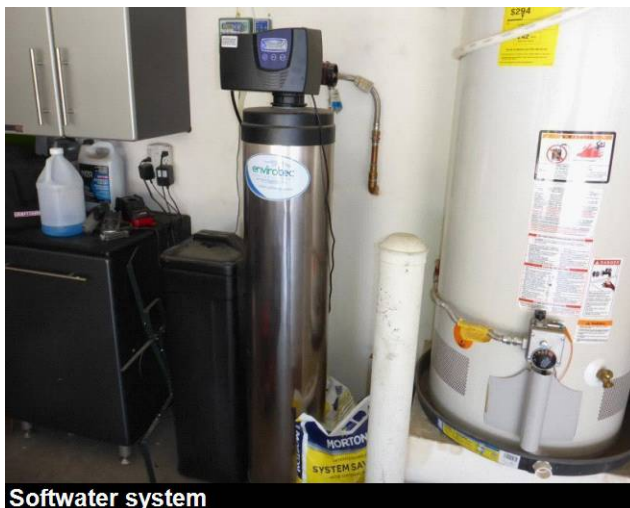
**Softwater system**

**Water softener installed but not within the scope of this inspection**

**We suggest that buyer reviews operation and maintenance schedule with seller to insure proper operation of unit.**

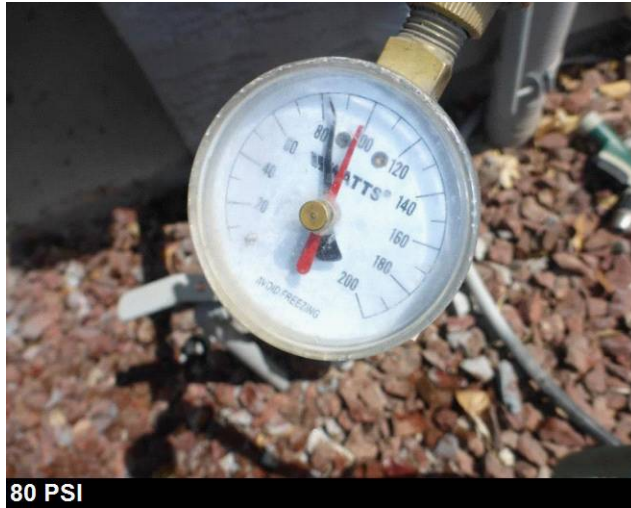
**80 PSI**

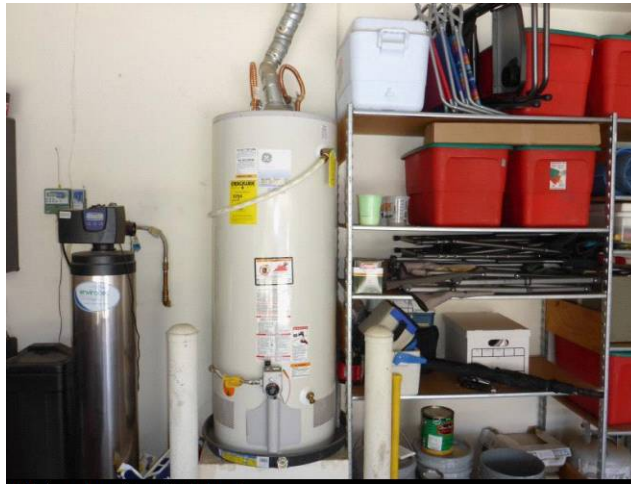
**Water heater & label**

2011 dated Unit. 4 years old.  
Industry average life for a gas water heater is 7- 10 years.

Water heater unit observed in good condition. No damaged or deterioration observed.

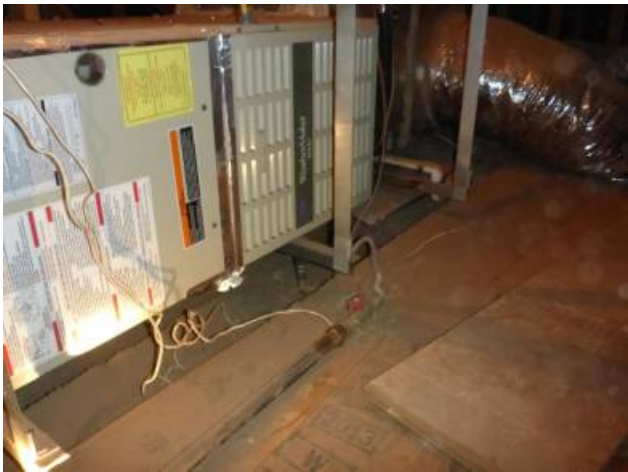
Attic with drip pan observed in good condition.

Recommend cleaning insulation debris out of the north rip pan.

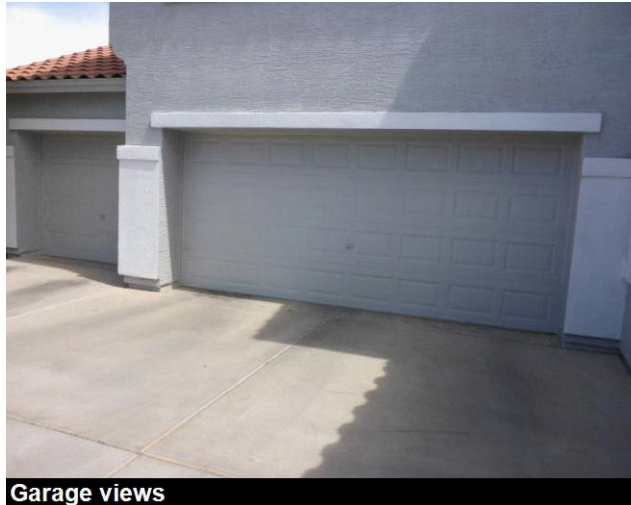
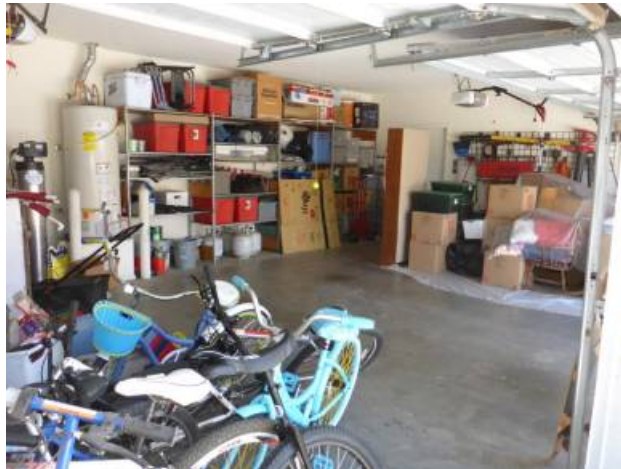
Garage views

**What could be seen observed in good condition however floor /wall areas were not fully visible at time of inspection due to seller/tenant's stored items covering approximately 50% of garage surface area.**

**Recommend reviewing entire wall/floor areas after stored items have been removed.**

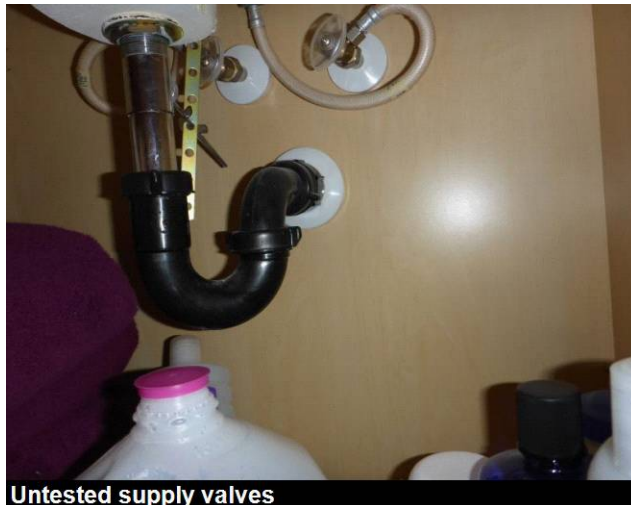
**Untested supply valves**
